Manhole Inspection Summary

Manhole # S19M__002MH

Insp Date: **3/26/08 9:28 AM**

Location Address: **478 s bentalou-ramsay alley**

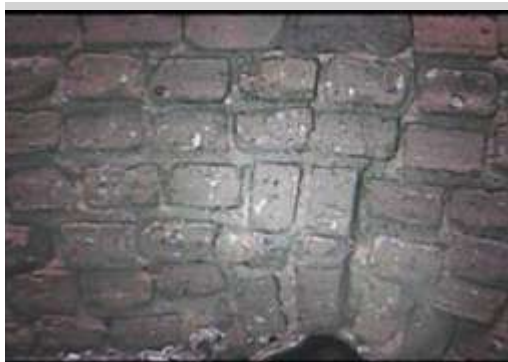
Defect 5

Condition: ☐ Sound ☒ **Cracked** ☐ Root Intrusion ☐ Loose Brick ☐ Deteriorated

crack in barrel wall

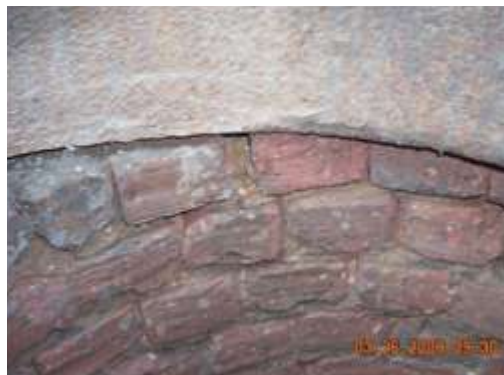
Defect 4

Condition: ☐ Sound ☐ Cracked ☐ Root Intrusion ☒ **Loose Brick** ☐ Deteriorated

loose corbel bricks

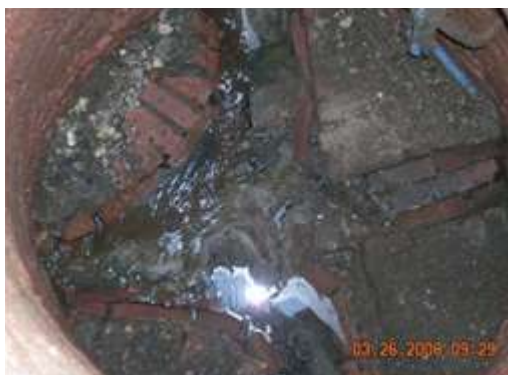
Defect 3

Condition: ☐ Sound ☐ Cracked ☐ Root Intrusion ☐ Deteriorated ☐ Leaks ☒ **Debris**

debris in channel

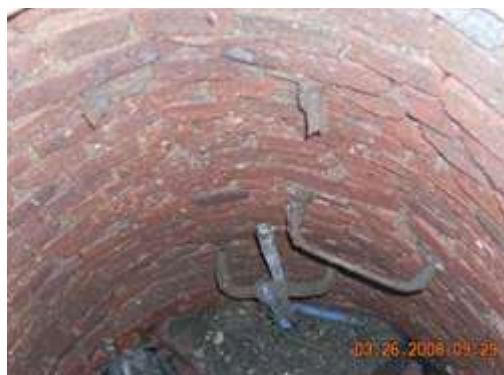
Defect 2

Steps Count: **2** Missing: **1** ☒ **Corroded**

corroded and missing steps

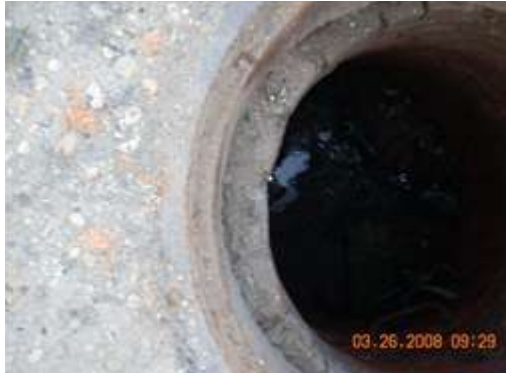
Defect 1

Frame Offset: **3** (in.) Condition: ☒ Sound ☐ Cracked ☐ Leaks

frame offset

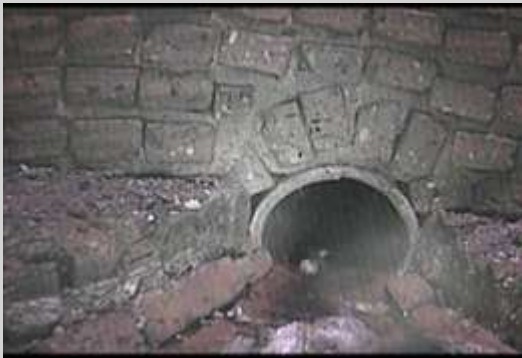
12 O'Clock Outflow

8 in. Circular Gravity Sewer
Pipe Out @ 12 O'Clock

Pipe Height: **7.2** (in.) Rod and Bar (Angled)
Pipe Material: **Clay** ☐ Pipe Lined
Invert Depth: **8.83** (ft.) Flow Characteristics: **Slow**
Deposits: ☐ None ☐ Mud ☒ **Sludge** ☐ Debris ☐ Grease
Silt Depth: **1** (in.) Deposits Extent: **Light**
Infiltration: **None** Pipe Seal Cond: **Sound**

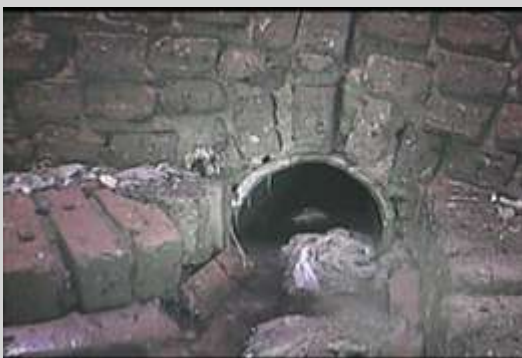
3 O'Clock Inflow

8 in. Circular Gravity Sewer
Pipe In @ 3 O'Clock

Pipe Height: **7.2** (in.) Rod and Bar (Angled)
Pipe Material: **Clay** ☐ Pipe Lined
Invert Depth: **8.74** (ft.) Flow Characteristics: **Slow**
Deposits: ☐ None ☐ Mud ☒ **Sludge** ☐ Debris ☐ Grease
Silt Depth: **2** (in.) Deposits Extent: **Light**
Infiltration: **None** Pipe Seal Cond: **Cracked**

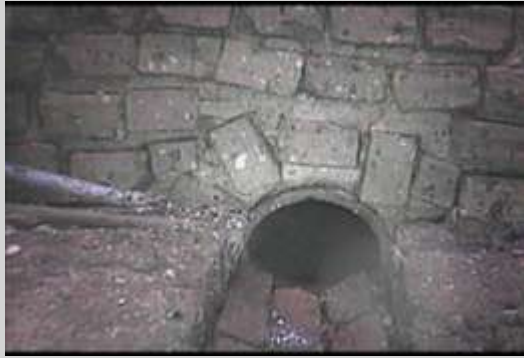
6 O'Clock Inflow

6 in. Circular Gravity Sewer

Pipe In @ 6 O'Clock

Invert Depth: **8.55** (ft.) Flow Characteristics: **Slow**

Deposits: ☒ None ☐ Mud ☐ ~~Sludge~~ ☐ Debris ☐ Grease

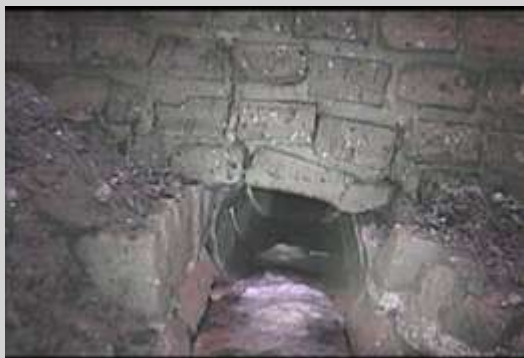
9 O'Clock Inflow

8 in. Circular Gravity Sewer

Pipe In @ 9 O'Clock

Deposits: ☐ None ☐ Mud ☒ ~~Sludge~~ ☐ Debris ☐ Grease

Silt Depth: **1** (in.) Deposits Extent: **Light**

Pipe Seal Cond: **Unknown**
